HARRIS CORP MELBOURNE FLA ELECTRONIC SYSTEMS DIV
QA PROCEDURES FOR COMPLEX MICROCIRCUITS. (U)
DEC 77 L R PARADISO, J L WOLCOTT

RADC-TR-77-418

| REPORT DOCUMENTATION PAGE | | READ INSTRUCTIONS BEFORE COMPLETING FORM |
|---|--|---|
| 4. TITLE (and Subtitle) QA PROCEDURES FOR COMPLEX MICROCIRCUITS. | 5. TYPE OF REPORT & PERIOD COVERED Final Technical Report, Jul. 1976 - Jul. 1977 | 6. PERFORMING ORG. REPORT NUMBER N/A |

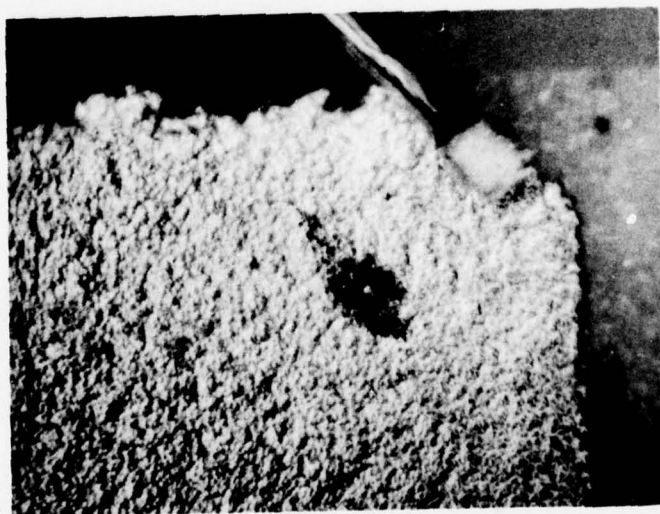
FIGURE E-4

TYPICAL OF THE LIFE TEST FAILURES
